REMOVAL REPORT
FOR
DIAZ INTERMEDIATES CORPORATION SITE
301 WYANOKE ROAD
WEST MEMPHIS, CRITTENDEN COUNTY, ARKANSAS

**REMOVAL ASSESSMENT REPORT
FOR
DIAZ INTERMEDIATES CORPORATION SITE

301 WYANOKE ROAD
WEST MEMPHIS, CRITTENDEN COUNTY, ARKANSAS**

Date Prepared:
October 27, 2008

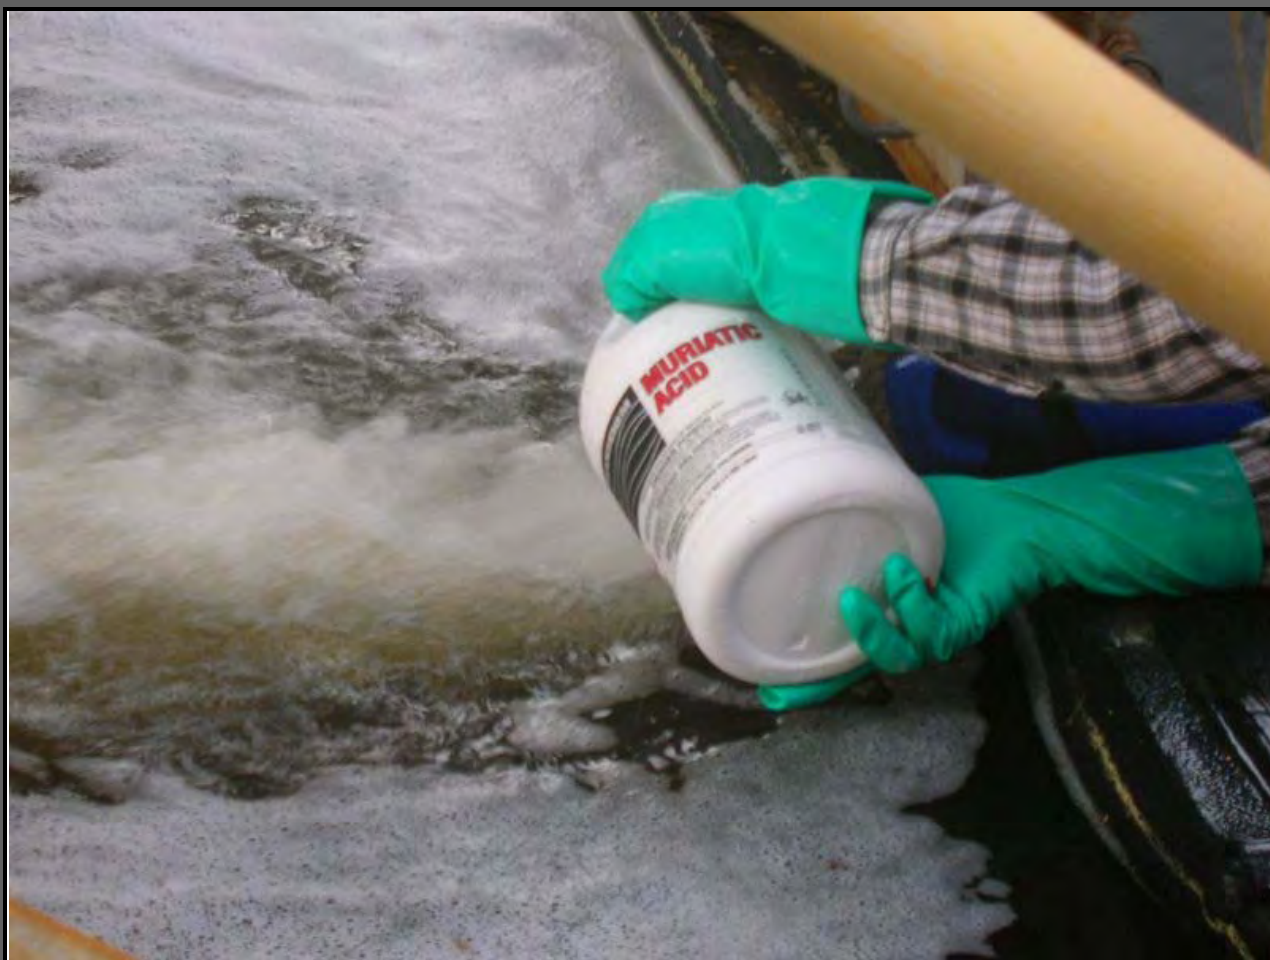
Logbook Photo #	090
US EPA ID / Task Order Number	ARR000005843 / TO-0001-08-01-01
Site	Diaz Intermediates Corporation
Location Address	301 Wyanoke Road
City, State, ZIP code	West Memphis, Arkansas 72301
County	Crittenden
Direction/Orientation	North-Northwest
Date	04/03/08
Time	1655
Photographer	Troy Naquin, Dynamac START-3
Witness	NA
Description: Adding muriatic acid to lower the pH in the pooled storm water in the Old Tank Farm secondary containment area.

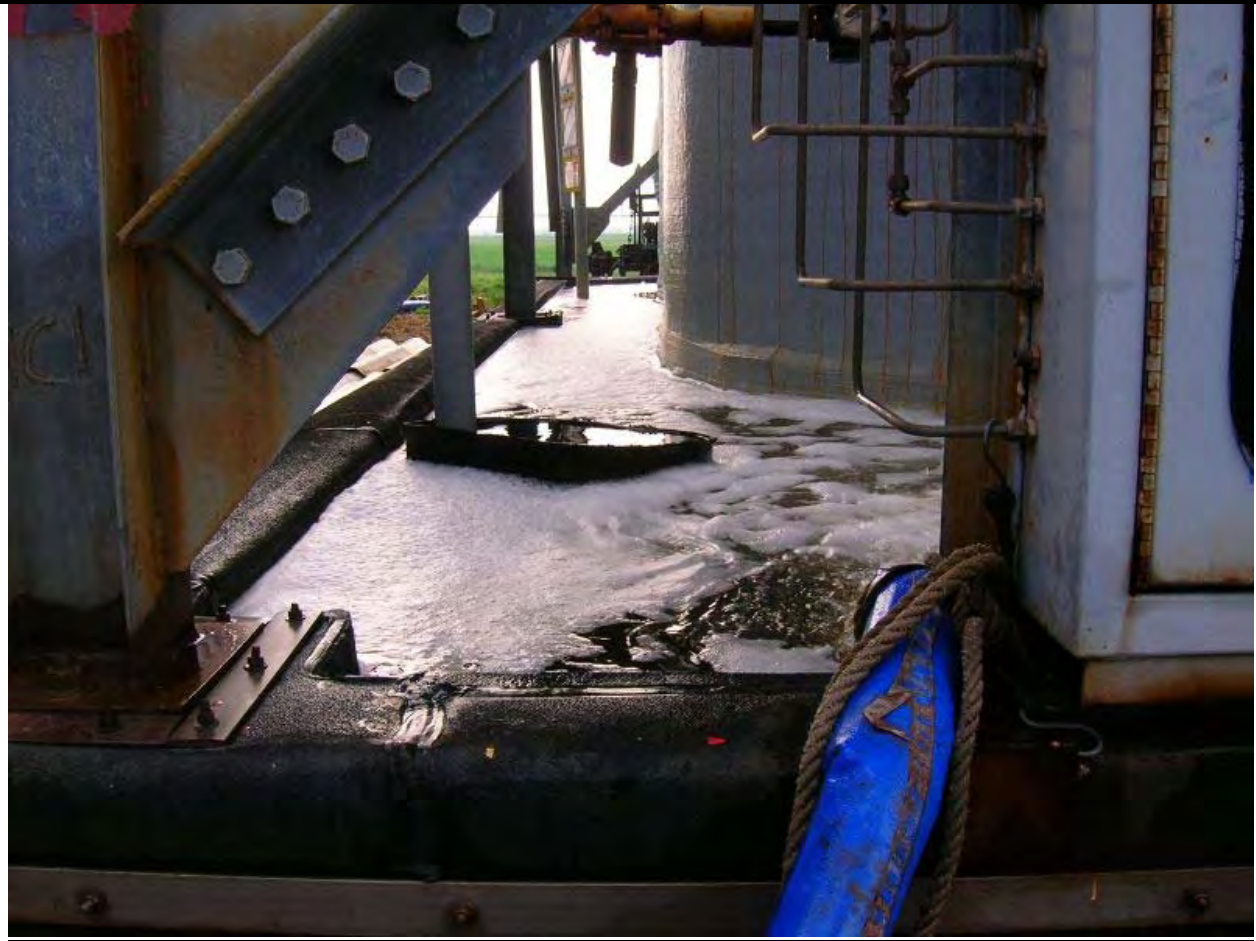
Logbook Photo #	091
US EPA ID / Task Order Number	ARR000005843 / TO-0001-08-01-01
Site	Diaz Intermediates Corporation
Location Address	301 Wyanoke Road
City, State, ZIP code	West Memphis, Arkansas 72301
County	Crittenden
Direction/Orientation	West
Date	04/03/08
Time	1657
Photographer	Troy Naquin, Dynamac START-3
Witness	NA
Description: Circulating storm water in the Old Tank Farm secondary containment area after adding muriatic acid.

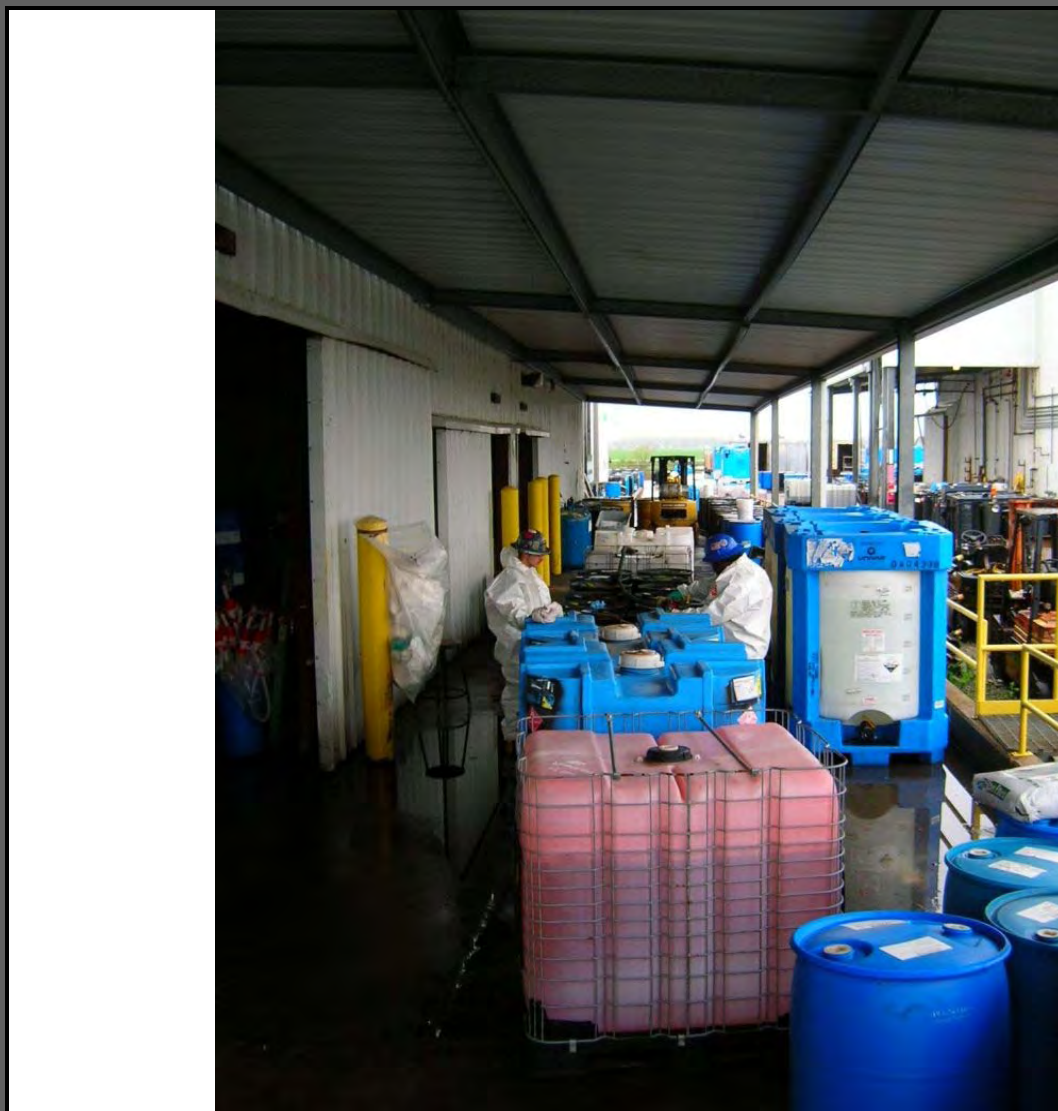
Logbook Photo #	092
US EPA ID / Task Order Number	ARR000005843 / TO-0001-08-01-01
Site	Diaz Intermediates Corporation
Location Address	301 Wyanoke Road
City, State, ZIP code	West Memphis, Arkansas 72301
County	Crittenden
Direction/Orientation	North
Date	04/04/08
Time	0859
Photographer	Troy Naquin, Dynamac START-3
Witness	NA
Description: ERRS transferring the contents from deteriorating drums into tote tanks.

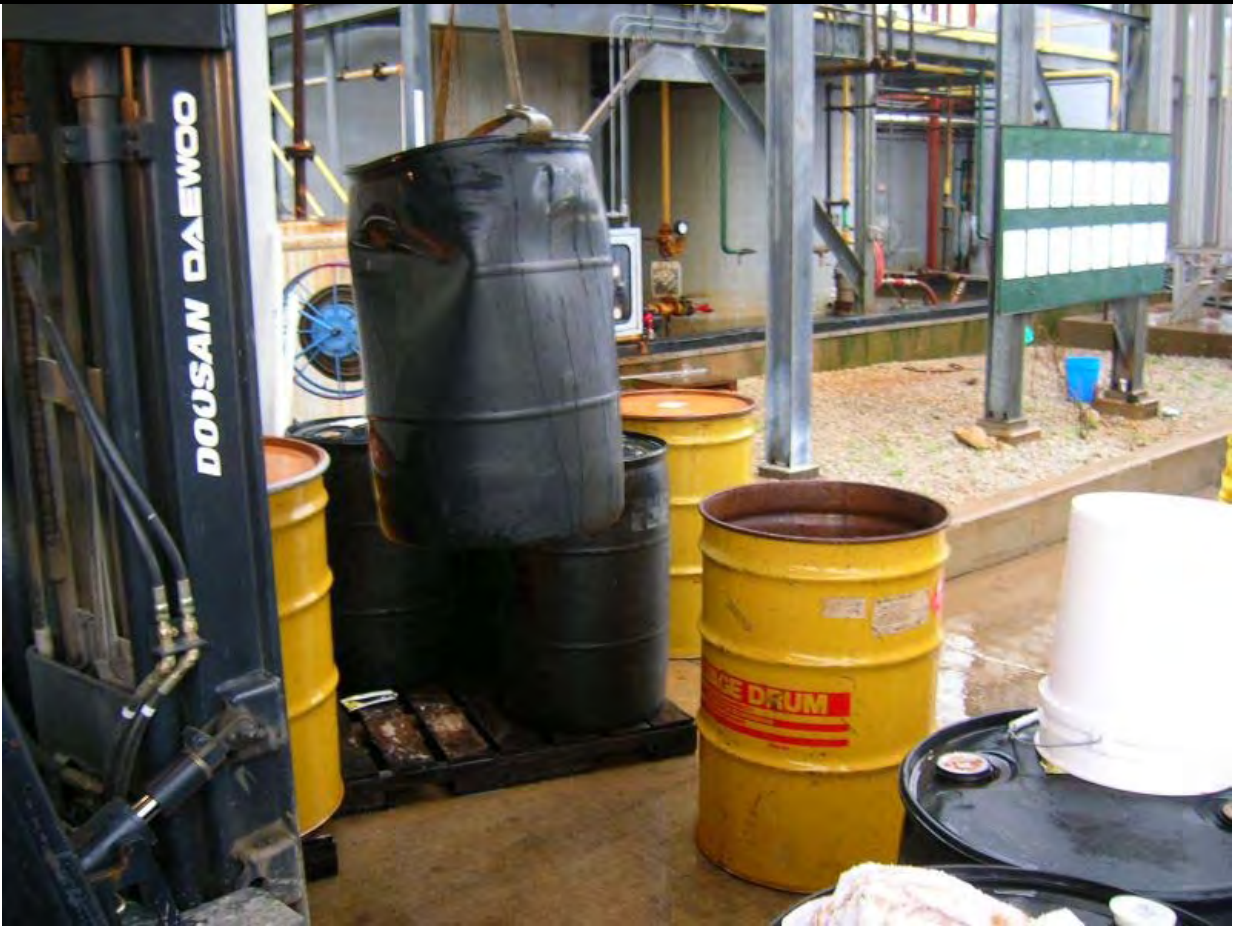
Logbook Photo #	093
US EPA ID / Task Order Number	ARR000005843 / TO-0001-08-01-01
Site	Diaz Intermediates Corporation
Location Address	301 Wyanoke Road
City, State, ZIP code	West Memphis, Arkansas 72301
County	Crittenden
Direction/Orientation	South
Date	04/04/08
Time	0901
Photographer	Troy Naquin, Dynamac START-3
Witness	NA
Description: ERRS transferring the contents from deteriorating drums into tote tanks.

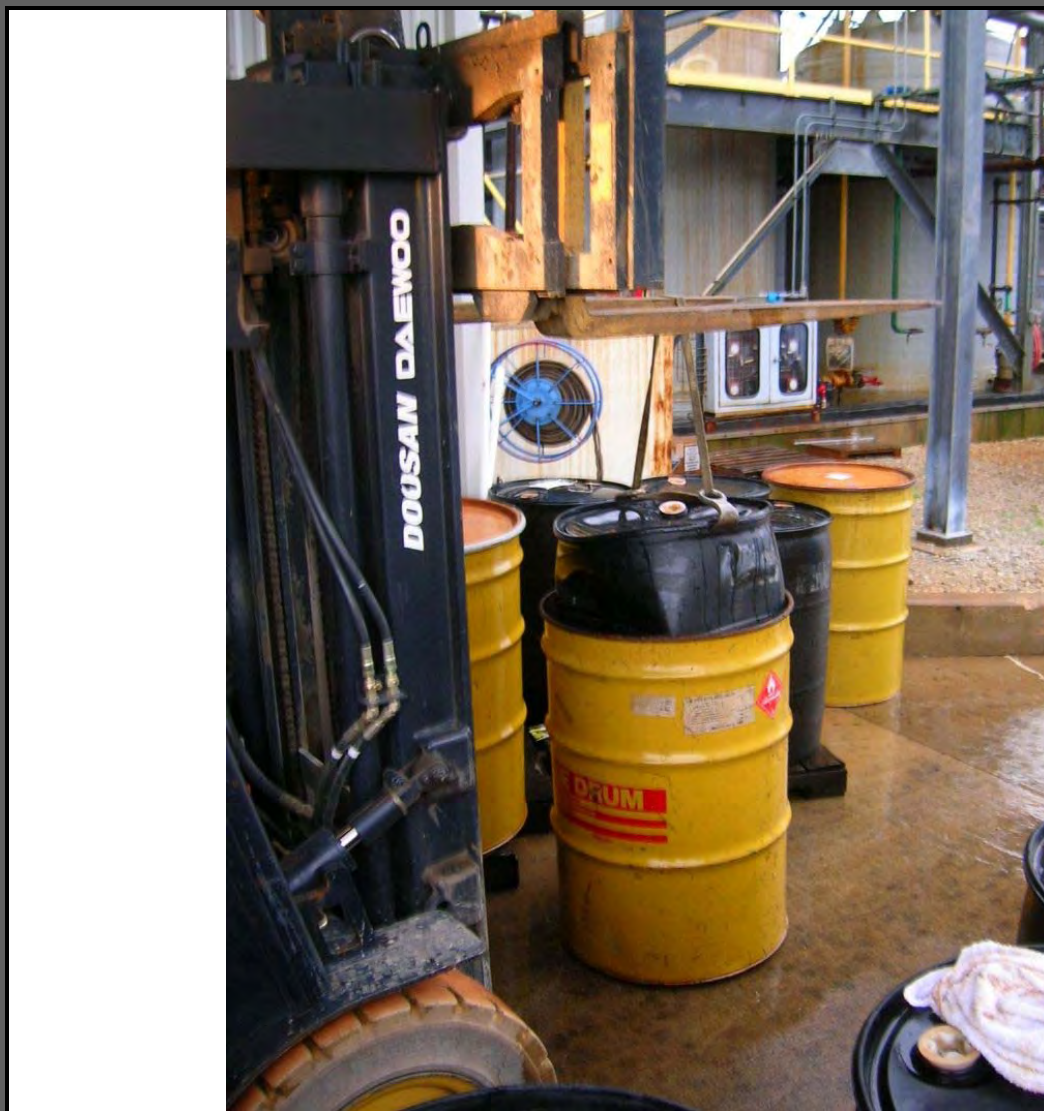
Logbook Photo #	094
US EPA ID / Task Order Number	ARR000005843 / TO-0001-08-01-01
Site	Diaz Intermediates Corporation
Location Address	301 Wyanoke Road
City, State, ZIP code	West Memphis, Arkansas 72301
County	Crittenden
Direction/Orientation	Northwest
Date	04/04/08
Time	0903
Photographer	Troy Naquin, Dynamac START-3
Witness	NA
Description: ERRS overpacking collapsed bromofluorobenzene drums.

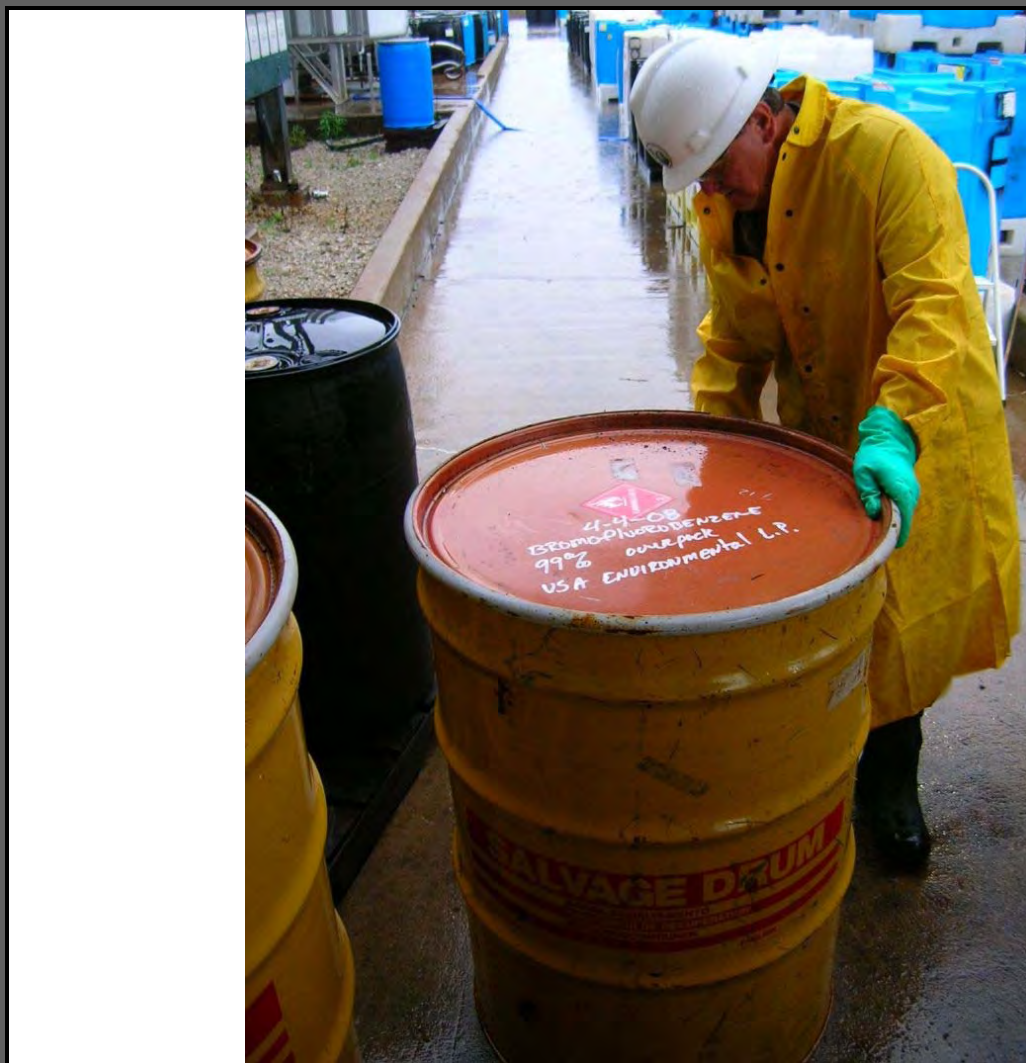
Logbook Photo #	095
US EPA ID / Task Order Number	ARR000005843 / TO-0001-08-01-01
Site	Diaz Intermediates Corporation
Location Address	301 Wyanoke Road
City, State, ZIP code	West Memphis, Arkansas 72301
County	Crittenden
Direction/Orientation	Northwest
Date	04/04/08
Time	0903
Photographer	Troy Naquin, Dynamac START-3
Witness	NA
Description: ERRS overpacking collapsed bromofluorobenzene drums.

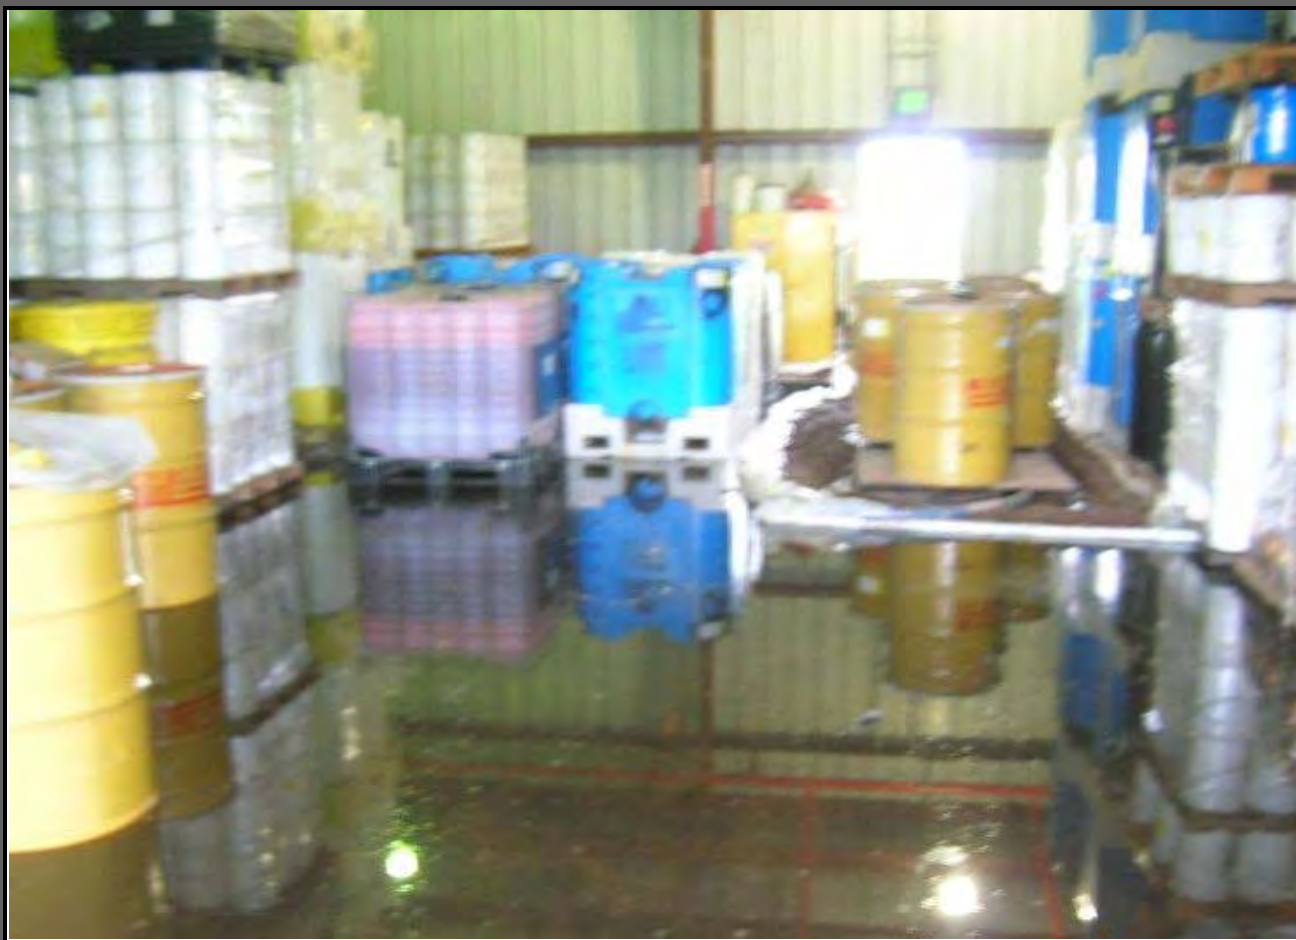
Logbook Photo #	096
US EPA ID / Task Order Number	ARR000005843 / TO-0001-08-01-01
Site	Diaz Intermediates Corporation
Location Address	301 Wyanoke Road
City, State, ZIP code	West Memphis, Arkansas 72301
County	Crittenden
Direction/Orientation	North
Date	04/04/08
Time	0906
Photographer	Troy Naquin, Dynamac START-3
Witness	NA
Description: ERRS overpacking collapsed bromofluorobenzene drums.

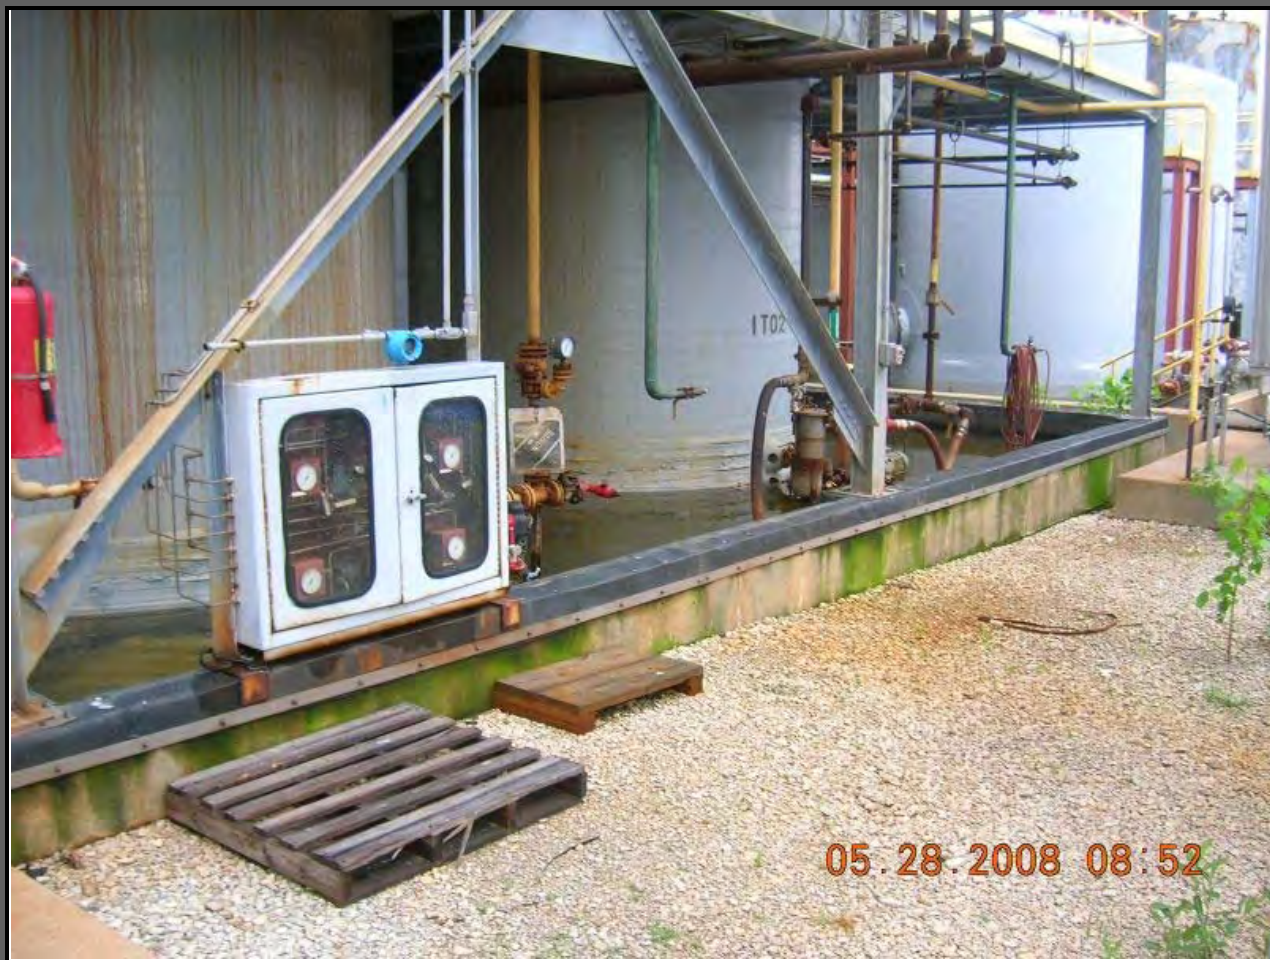
Logbook Photo #	097
US EPA ID / Task Order Number	ARR000005843 / TO-0001-08-01-01
Site	Diaz Intermediates Corporation
Location Address	301 Wyanoke Road
City, State, ZIP code	West Memphis, Arkansas 72301
County	Crittenden
Direction/Orientation	West
Date	05/28/08
Time	0851
Photographer	Troy Naquin, Dynamac START-3
Witness	NA
Description: Pooled storm water in Warehouse prior to pumping out.

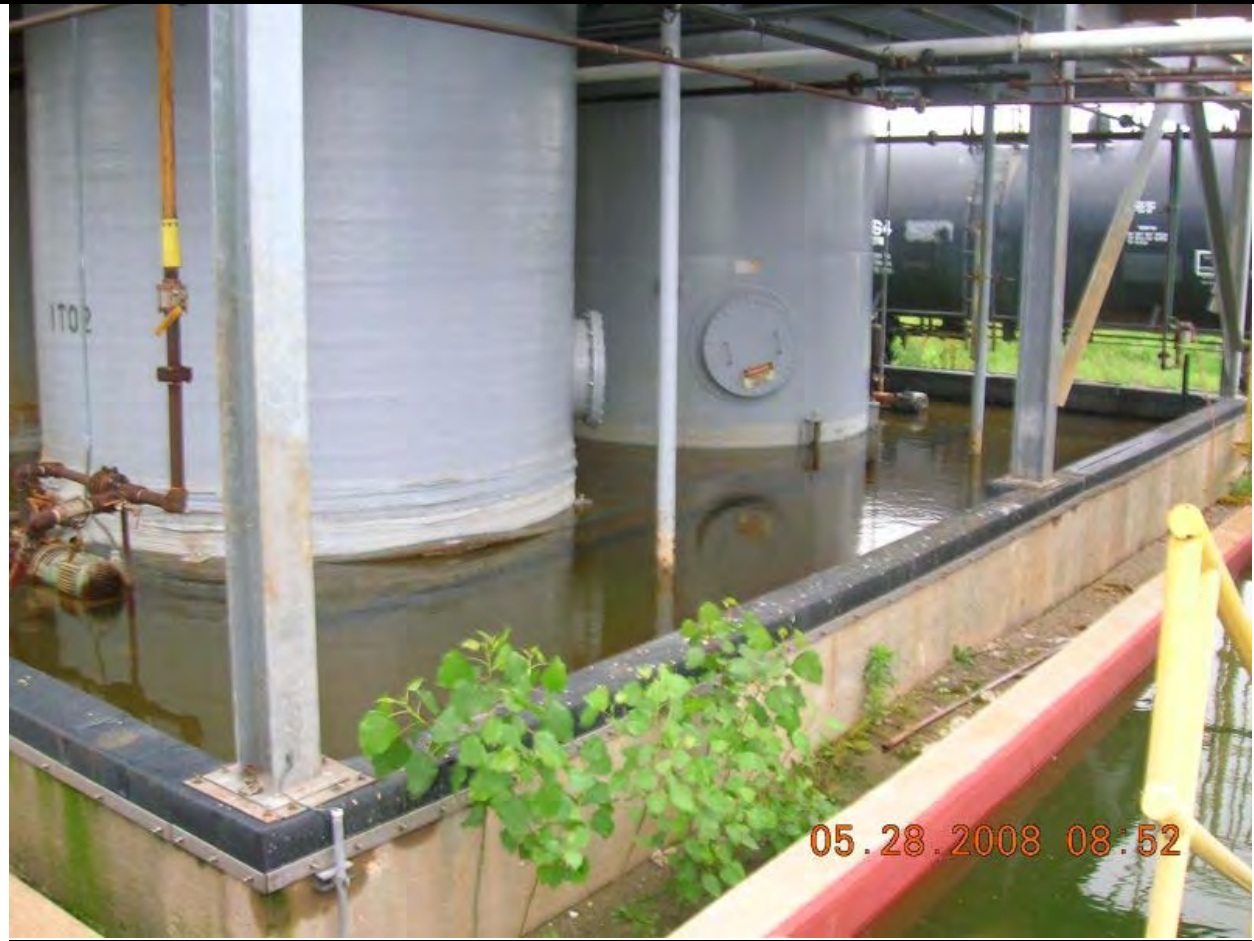
Logbook Photo #	098
US EPA ID / Task Order Number	ARR000005843 / TO-0001-08-01-01
Site	Diaz Intermediates Corporation
Location Address	301 Wyanoke Road
City, State, ZIP code	West Memphis, Arkansas 72301
County	Crittenden
Direction/Orientation	Northwest
Date	05/28/08
Time	0852
Photographer	Troy Naquin, Dynamac START-3
Witness	NA
Description: Pooled storm water in Old Tank Farm secondary containment area prior to pumping out into sanitary sewer.

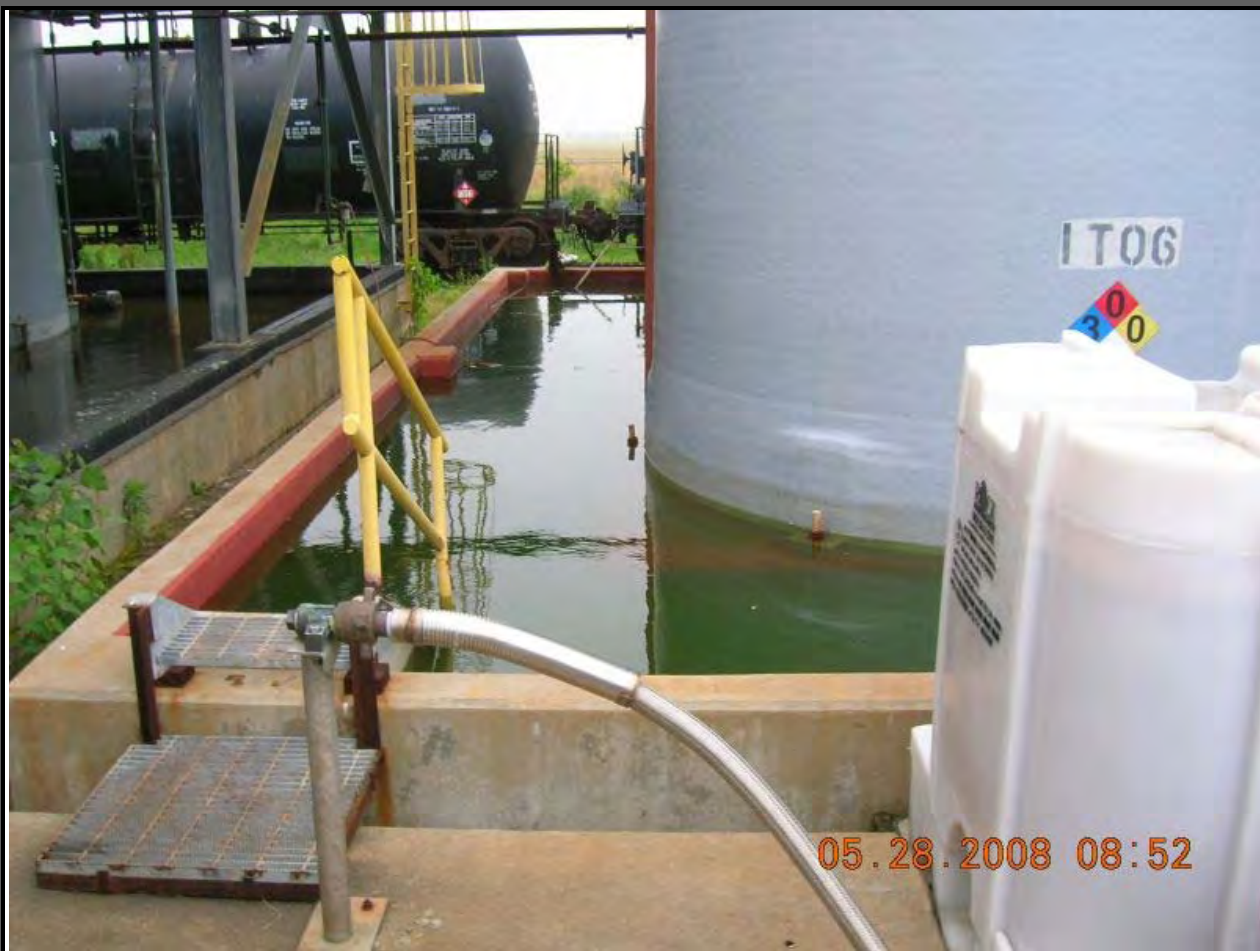
Logbook Photo #	099
US EPA ID / Task Order Number	ARR000005843 / TO-0001-08-01-01
Site	Diaz Intermediates Corporation
Location Address	301 Wyanoke Road
City, State, ZIP code	West Memphis, Arkansas 72301
County	Crittenden
Direction/Orientation	West - Southwest
Date	05/28/08
Time	0852
Photographer	Troy Naquin, Dynamac START-3
Witness	NA
Description:	Pooled storm water in Old Tank Farm secondary containment area prior to pumping out into sanitary sewer.

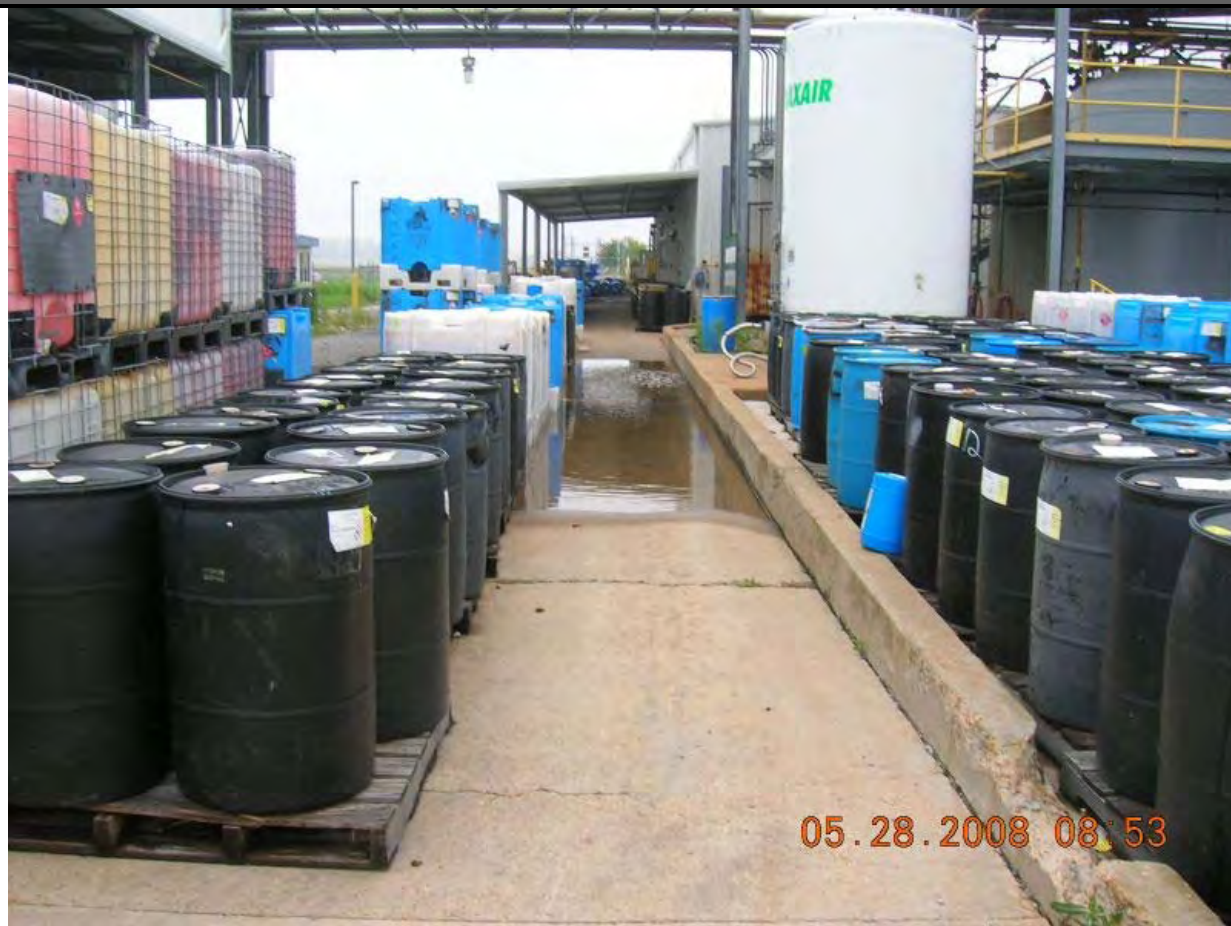
Logbook Photo #	100
US EPA ID / Task Order Number	ARR000005843 / TO-0001-08-01-01
Site	Diaz Intermediates Corporation
Location Address	301 Wyanoke Road
City, State, ZIP code	West Memphis, Arkansas 72301
County	Crittenden
Direction/Orientation	West
Date	05/28/08
Time	0852
Photographer	Troy Naquin, Dynamac START-3
Witness	NA
Description: Pooled storm water in New Tank Farm secondary containment area prior to pumping out into sanitary sewer.

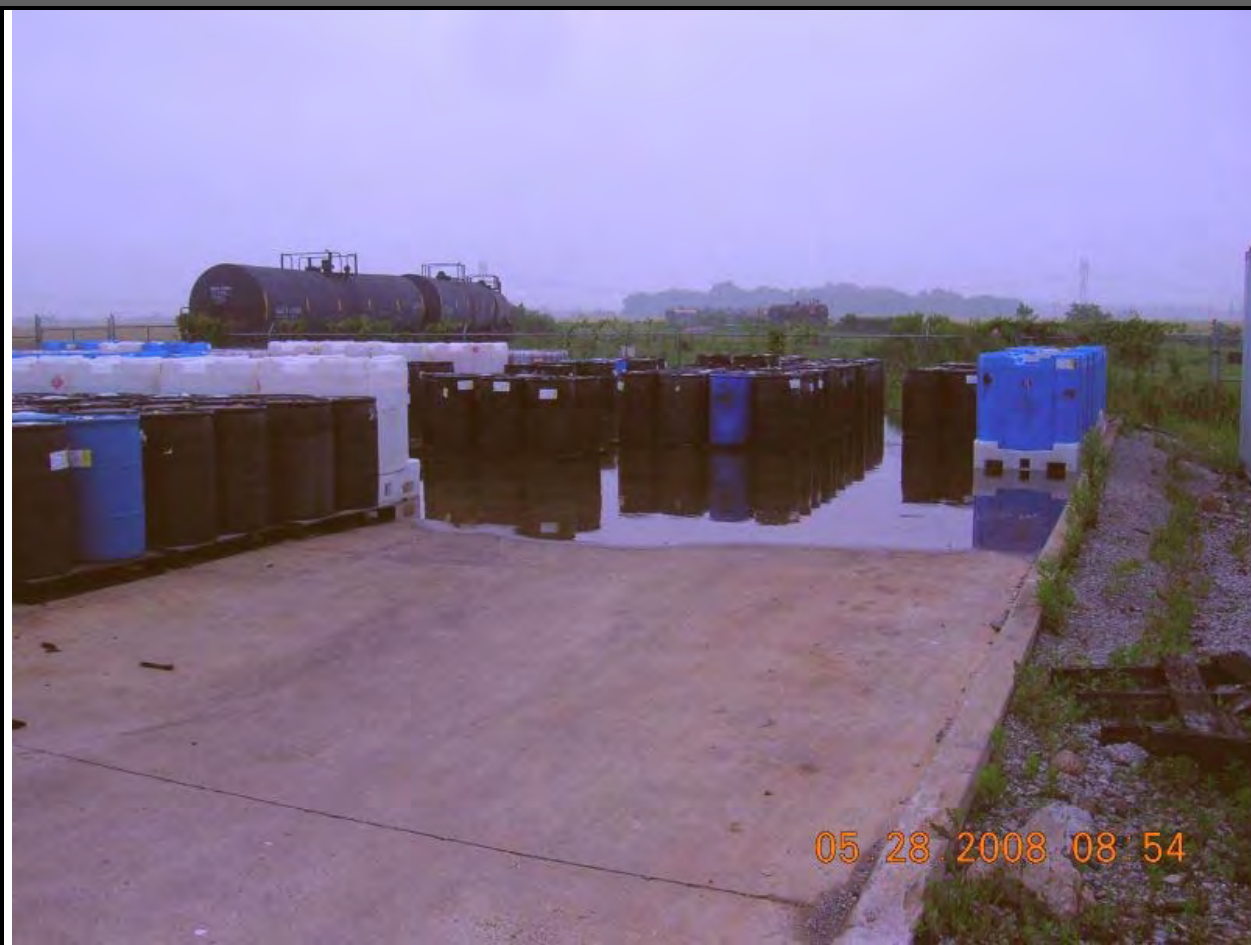
Logbook Photo #	101
US EPA ID / Task Order Number	ARR000005843 / TO-0001-08-01-01
Site	Diaz Intermediates Corporation
Location Address	301 Wyanoke Road
City, State, ZIP code	West Memphis, Arkansas 72301
County	Crittenden
Direction/Orientation	South
Date	05/28/08
Time	0853
Photographer	Troy Naquin, Dynamac START-3
Witness	NA
Description: Pooled storm water in Forklift Path area prior to pumping out into sanitary sewer.

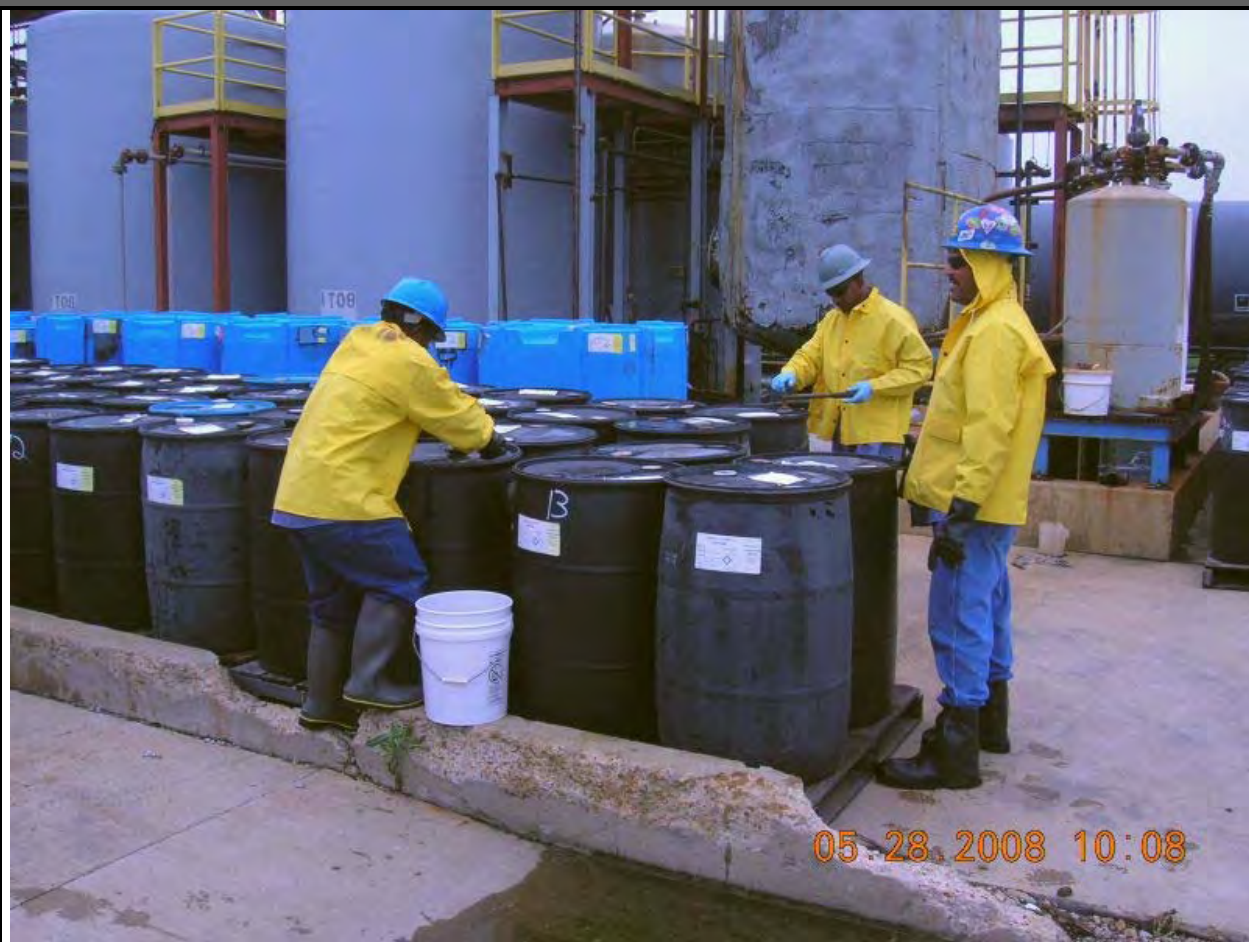
Logbook Photo #	102
US EPA ID / Task Order Number	ARR000005843 / TO-0001-08-01-01
Site	Diaz Intermediates Corporation
Location Address	301 Wyanoke Road
City, State, ZIP code	West Memphis, Arkansas 72301
County	Crittenden
Direction/Orientation	North
Date	05/28/08
Time	0854
Photographer	Troy Naquin, Dynamac START-3
Witness	NA
Description:	Pooled storm water in Drum Pad containment area prior to pumping out into the storm water drainage pathway.

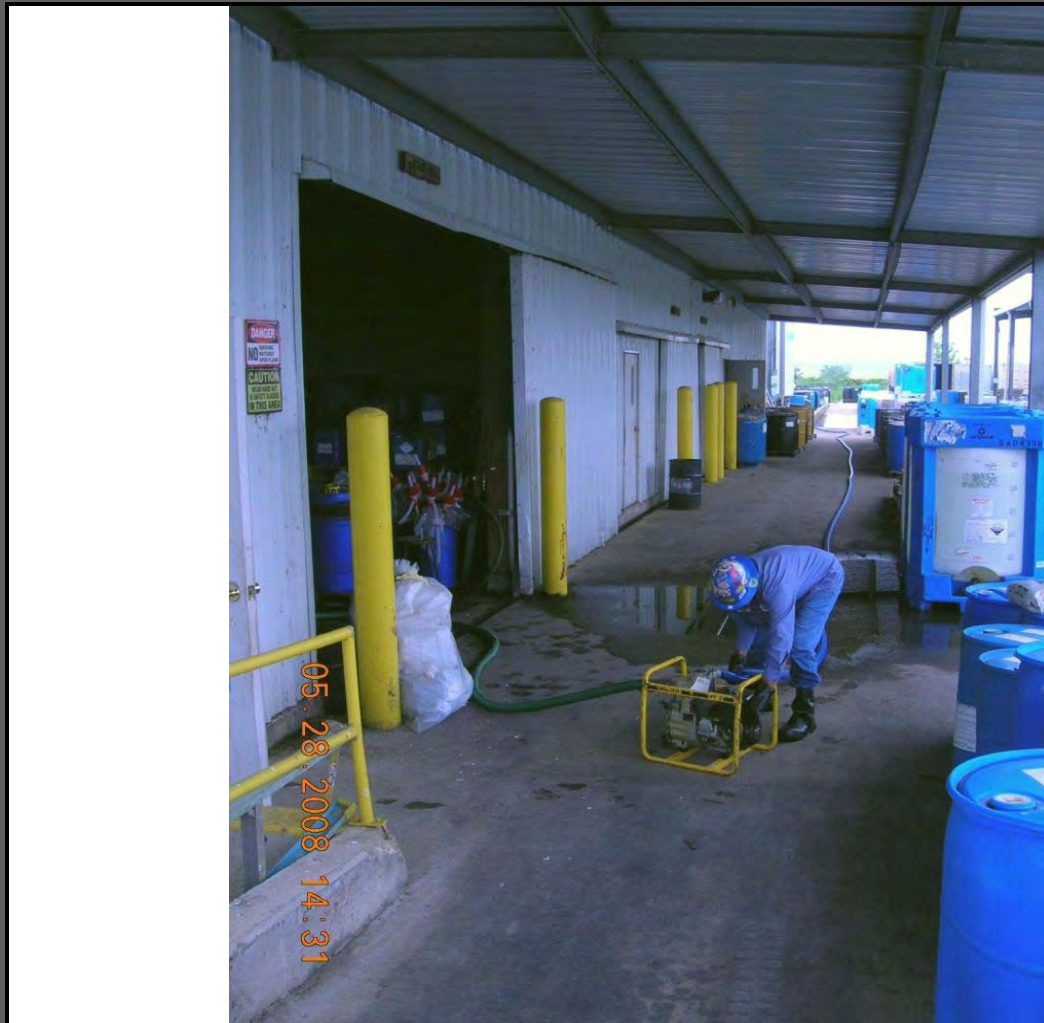
Logbook Photo #	103
US EPA ID / Task Order Number	ARR000005843 / TO-0001-08-01-01
Site	Diaz Intermediates Corporation
Location Address	301 Wyanoke Road
City, State, ZIP code	West Memphis, Arkansas 72301
County	Crittenden
Direction/Orientation	West - Southwest
Date	05/28/08
Time	1008
Photographer	Troy Naquin, Dynamac START-3
Witness	NA
Description: ERRS changing out and securing drum bungs.

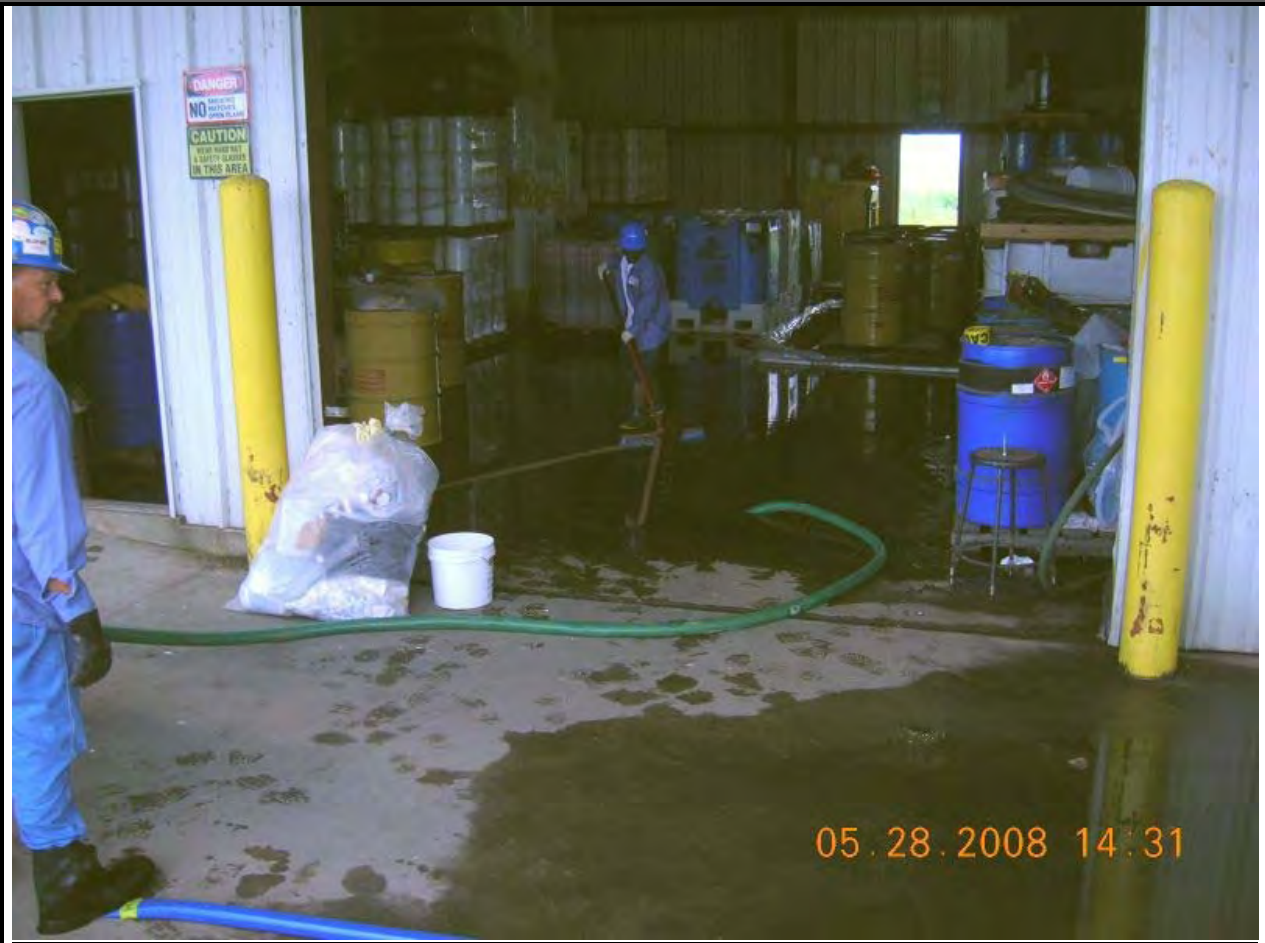
Logbook Photo #	104
US EPA ID / Task Order Number	ARR000005843 / TO-0001-08-01-01
Site	Diaz Intermediates Corporation
Location Address	301 Wyanoke Road
City, State, ZIP code	West Memphis, Arkansas 72301
County	Crittenden
Direction/Orientation	North
Date	05/28/08
Time	1431
Photographer	Troy Naquin, Dynamac START-3
Witness	NA
Description: Pumping out pooled storm water from Warehouse into the Old Tank Farm secondary containment area.

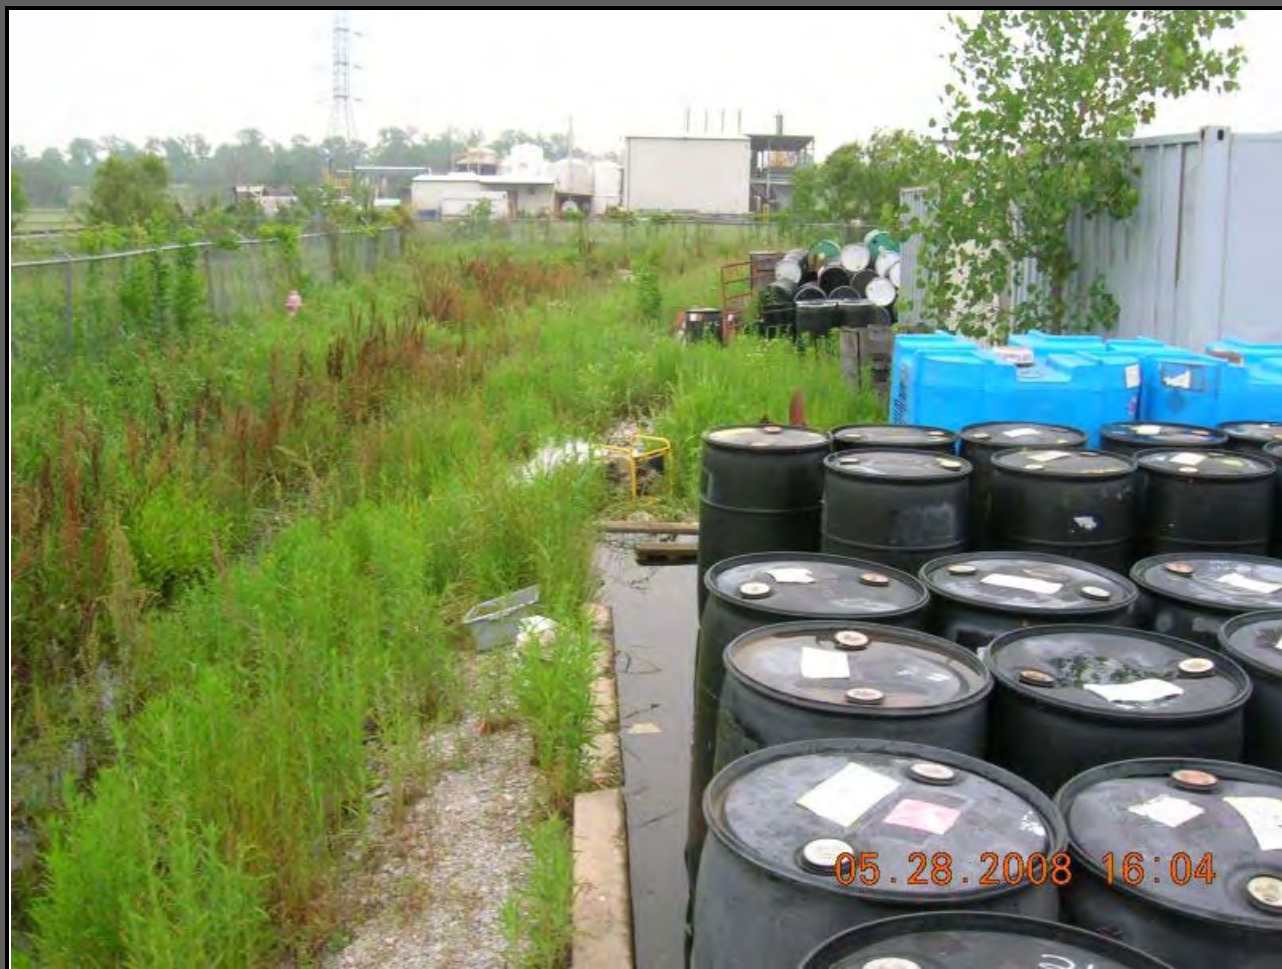
Logbook Photo #	105
US EPA ID / Task Order Number	ARR000005843 / TO-0001-08-01-01
Site	Diaz Intermediates Corporation
Location Address	301 Wyanoke Road
City, State, ZIP code	West Memphis, Arkansas 72301
County	Crittenden
Direction/Orientation	West
Date	05/28/08
Time	1431
Photographer	Troy Naquin, Dynamac START-3
Witness	NA
Description:	Pumping out pooled storm water from Warehouse into the Old Tank Farm secondary containment area.

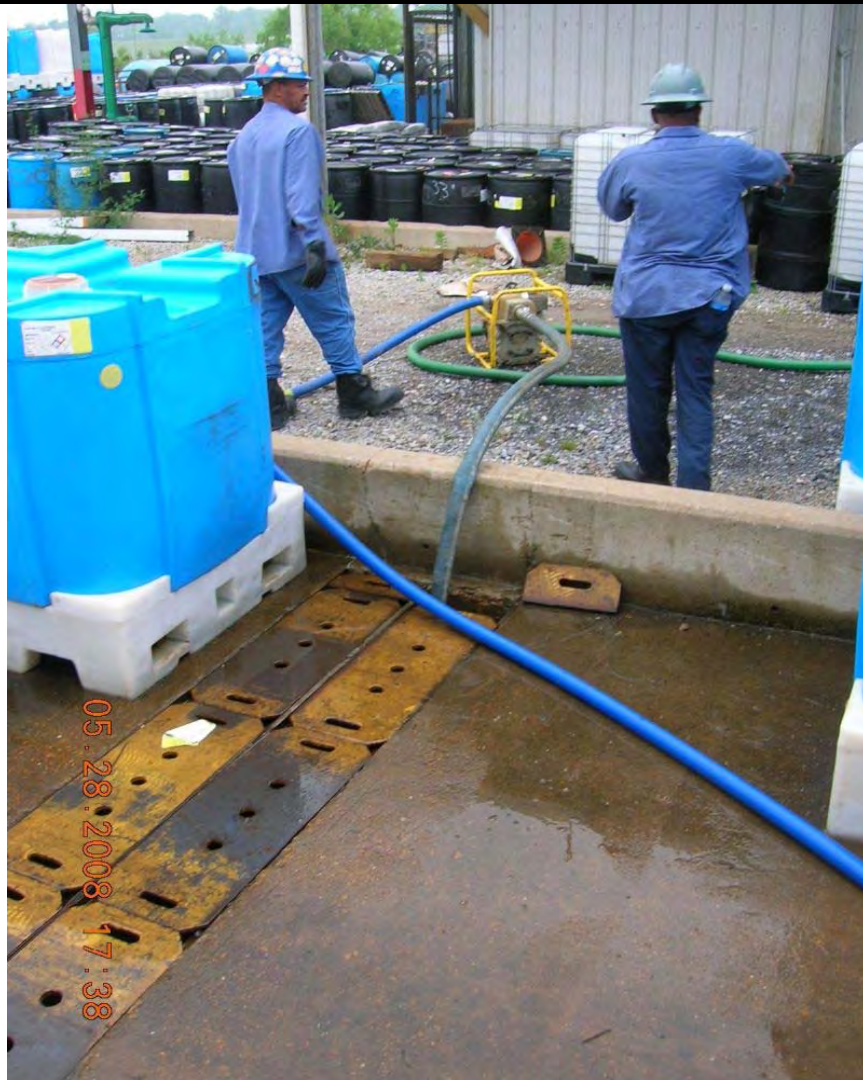
Logbook Photo #	106
US EPA ID / Task Order Number	ARR000005843 / TO-0001-08-01-01
Site	Diaz Intermediates Corporation
Location Address	301 Wyanoke Road
City, State, ZIP code	West Memphis, Arkansas 72301
County	Crittenden
Direction/Orientation	East
Date	05/28/08
Time	1604
Photographer	Troy Naquin, Dynamac START-3
Witness	NA
Description: Pumping out pooled storm water from the Drum Pad containment area into the storm water drainage pathway.

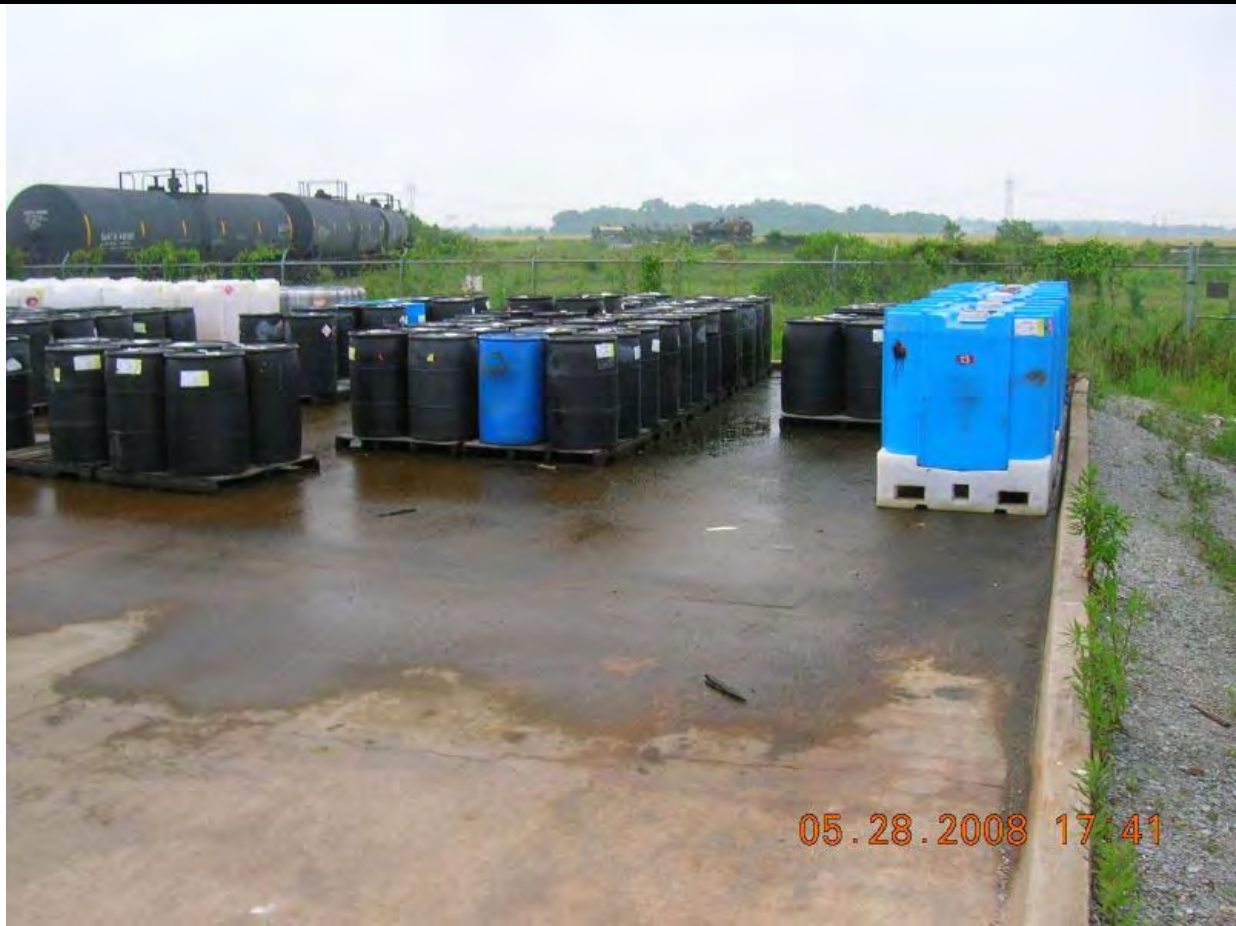
Logbook Photo #	107
US EPA ID / Task Order Number	ARR000005843 / TO-0001-08-01-01
Site	Diaz Intermediates Corporation
Location Address	301 Wyanoke Road
City, State, ZIP code	West Memphis, Arkansas 72301
County	Crittenden
Direction/Orientation	East - Northeast
Date	05/28/08
Time	1738
Photographer	Troy Naquin, Dynamac START-3
Witness	NA
Description: Pumping out pooled storm water from the Forklift Pad area into the Old Tank Farm secondary containment area.
